# On Historic Preservation

## Saving a Landmark

By Robert J. Nacheman, P.E. (RNacheman@ThorntonTomasetti.com)

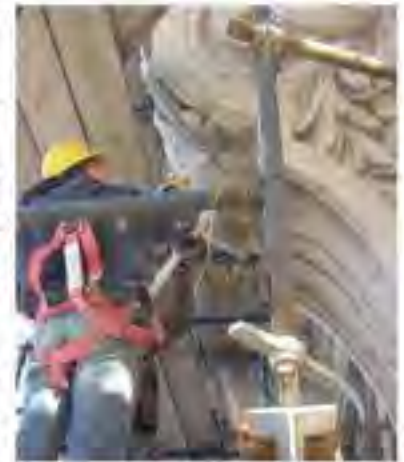
Grout being pumped into the terra cotta anchor assembly to engage and stabilize terra cotta units.

We specified stainless steel anchors set in pressure-grouted fabric socks in the cracked terra cotta brackets, and stainless steel staples at the building's corner cracks.

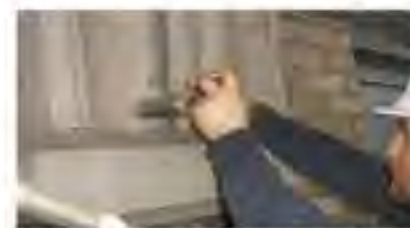
To correlate the degree of cracking visible at the surface with the amount of subsurface corrosion, we conducted invasive probes at the building corners and terra cotta enclosed decorative façade columns and brackets. Pulse echo scans were also performed on the terra cotta brackets to identify internal cracking.

Pulse echo scanning of terra cotta.
